# National Transportation Safety Board Aviation Accident Preliminary Report

<b>Location:</b>	Skwenta, AK	<b>Accident Number:</b>	ANC22LA080
<b>Date &amp; Time:</b>	September 25, 2022, 13:00 Local	<b>Registration:</b>	N9728B
<b>Aircraft:</b>	Cessna 180A	<b>Injuries:</b>	1 Fatal
<b>Flight Conducted Under:</b>	Part 91: General aviation - Personal

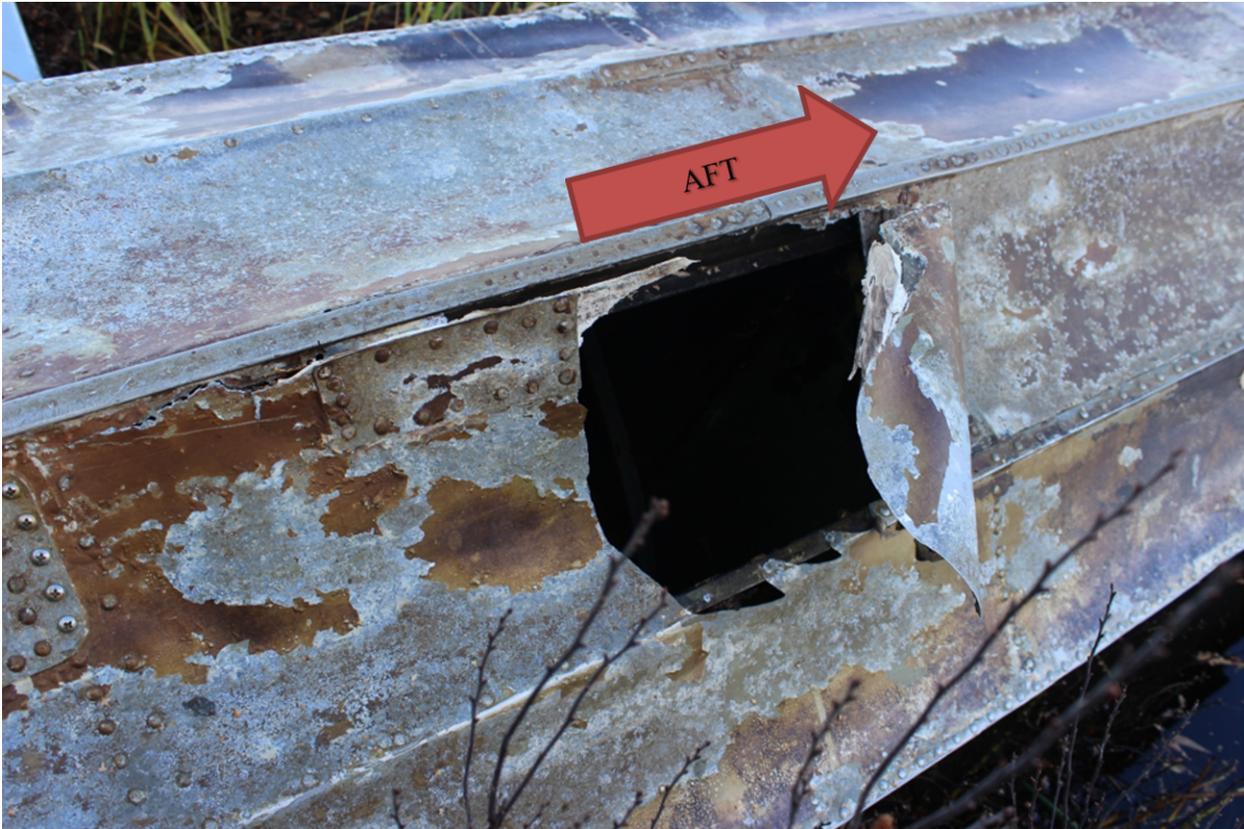
The bottoms of both floats were heavily corroded and discolored.

The right float remained attached to the airframe by the fly wire, and water rudder control cables. There were six patches of varying size noted on the hull of the right float. A portion of the float hull, about midspan from the tip of the float to the step, was partially separated and bent aft. (See Figure 1.)

Figure 1 View of partially separated section on hull of the right float.
