National Transportation Safety Board Aviation Accident Preliminary Report

Location:	Fairbanks, AK	Accident Number:	ANC23FA001
Date & Time:	October 5, 2022, 17:58 Local	Registration:	N217C
Aircraft:	Cessna A185F	Injuries:	1 Fatal
Flight Conducted Under:	Part 91: General aviation - Personal

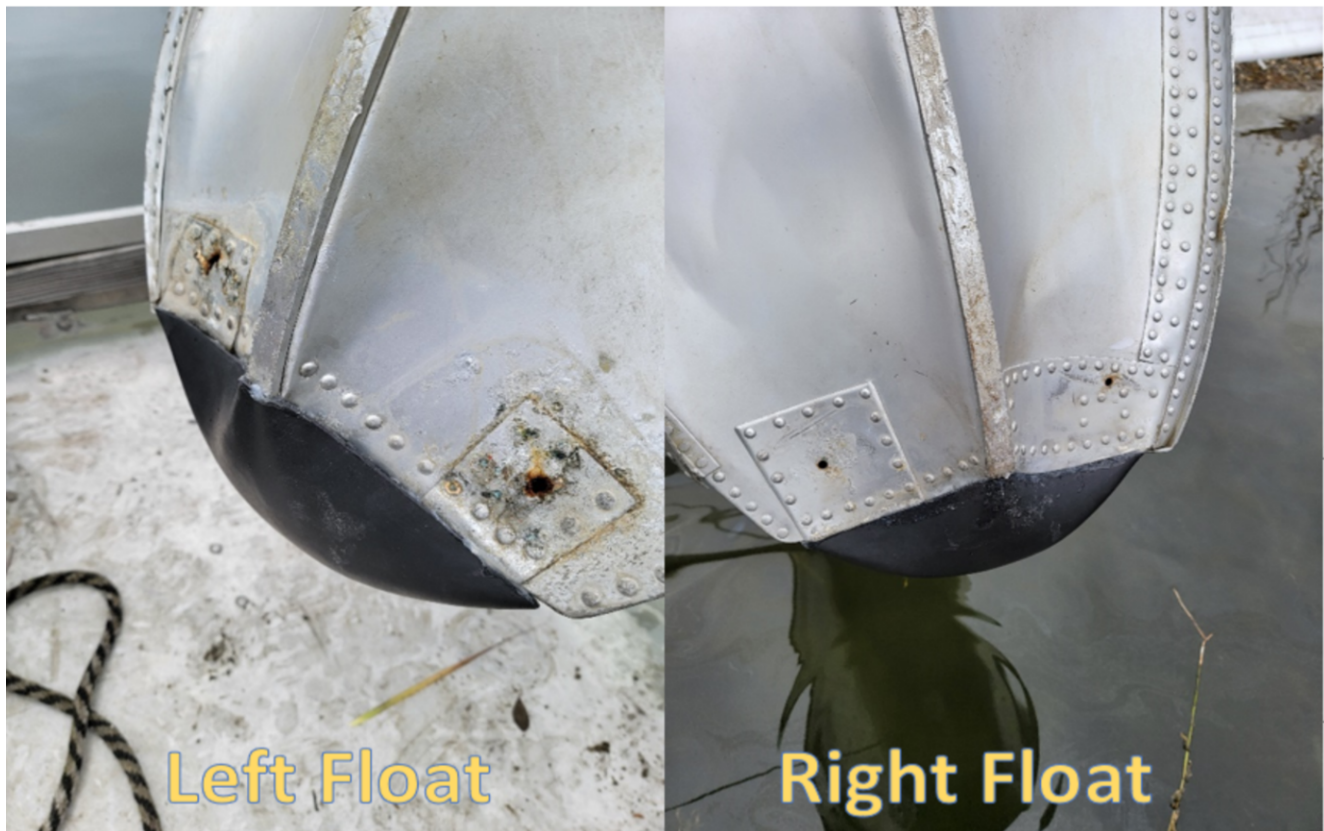
The NTSB on scene examination of the accident airplane's floats revealed a substantial amount of cargo was being transported within the left float locker. Additionally, two unplugged holes were found under each front float bumper. (See Figure 1.)

The accident airplane was equipped with a set of EDO 3430 floats.

Figure 1. Underside view of the left and right float
