Aviation Investigation Preliminary Report

Location:	Skwentna, AK	Accident Number:	ANC23FA061
Date & Time:	August 9, 2023, 12:15 Local	Registration:	N4481Z
Aircraft:	Piper PA-18-150	Injuries:	2 Fatal
Flight Conducted Under:	Part 135: Air taxi & commuter - Non-scheduled

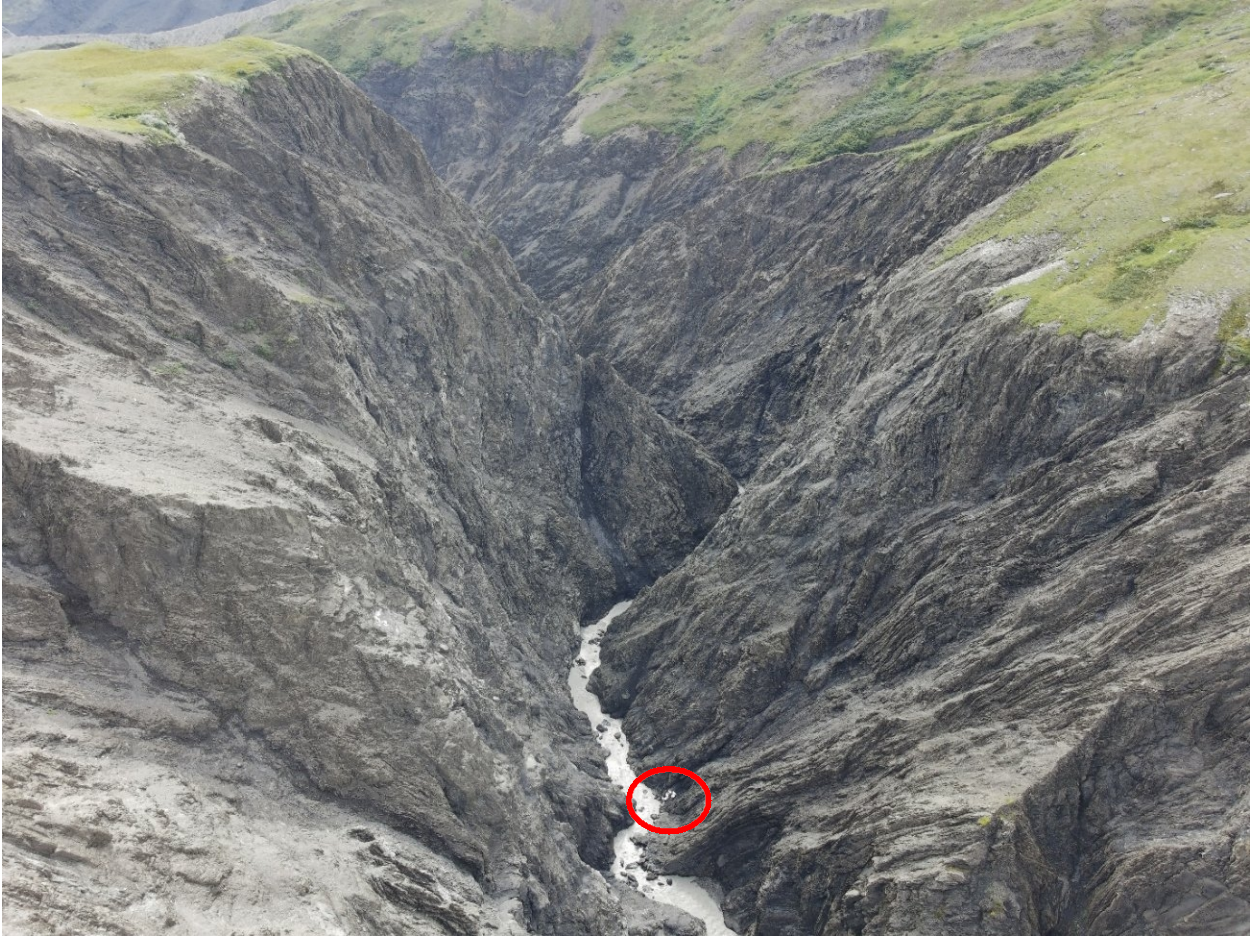
Search and rescue operations began that evening by the Alaska Air National Guard Rescue Coordination Center (AKRCC). Initial search flights were then suspended due to poor weather in the identified search area. On August 10th, about 0930, the airplane wreckage was located by the AKRCC at the bottom of an estimated 500 to 600 ft narrow ravine of the West Fork of the Yentna River, also known as Shellabarger Pass in Denali National Park and Preserve (see figures 2 and 3).

Figure 2. Accident site location (airplane circled in red)

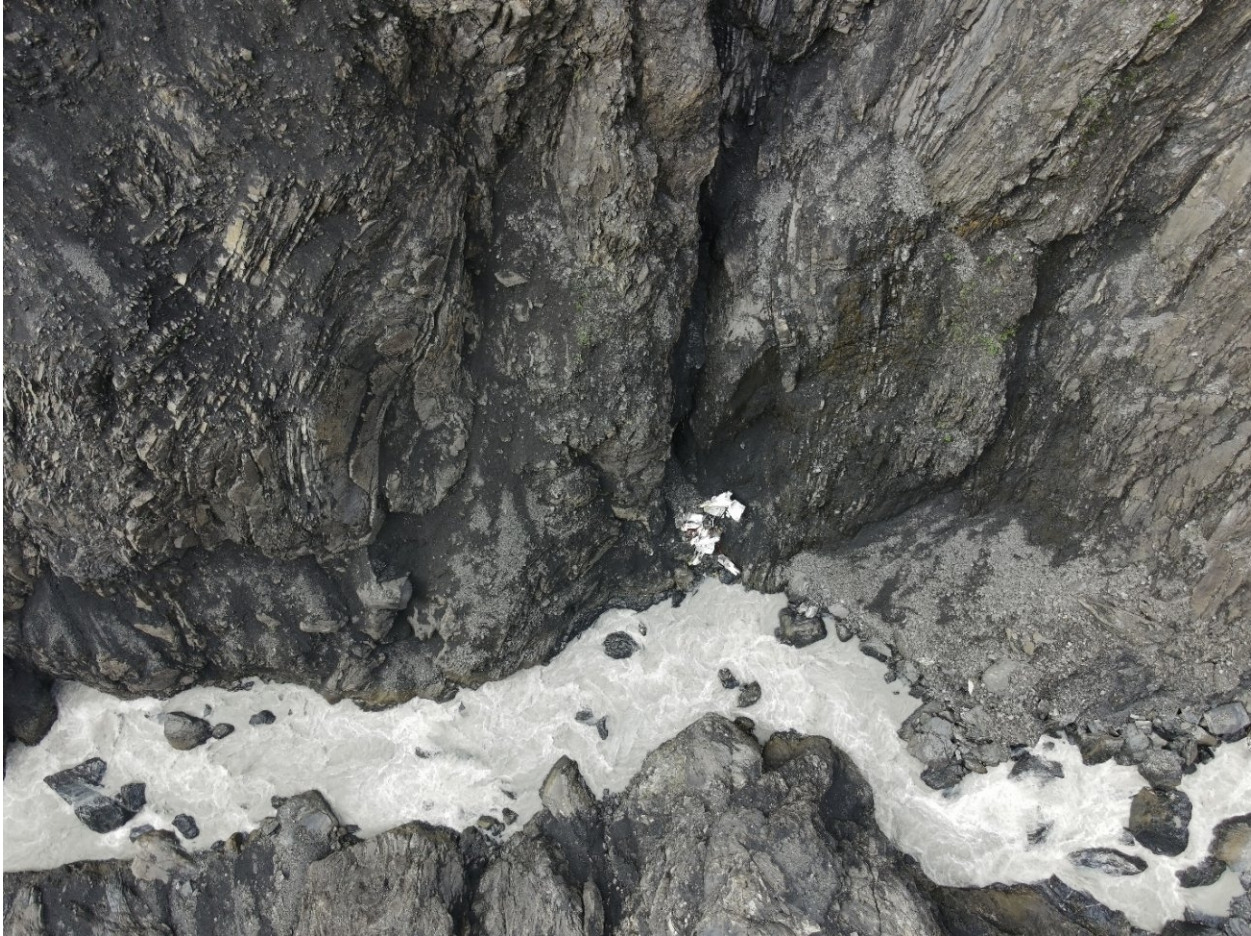
Figure 3. Airplane wreckage in bottom of ravine

On August 11th, the National Transportation Safety Board (NTSB) investigator-in-charge and Denali National Park rangers traveled to the accident site location by a National Park Service (NPS) helicopter, but the team was unable to access the accident site due to steep and unstable terrain conditions. The airplane wreckage was photographed by helicopter, and an NTSB drone was deployed to descend into the canyon to document the accident site and airplane wreckage. Airplane debris and non-aircraft gear were located on the canyon wall about 400 ft above the main wreckage.
