# Aviation Investigation Preliminary Report

<b>Location:</b>	St. Marys, AK	<b>Accident Number:</b>	ANC23FA074
<b>Date &amp; Time:</b>	September 12, 2023, 20:47 Local	<b>Registration:</b>	N109T
<b>Aircraft:</b>	Piper PA-18-150	<b>Injuries:</b>	1 Fatal
<b>Flight Conducted Under:</b>	Part 135: Air taxi & commuter - Non-scheduled

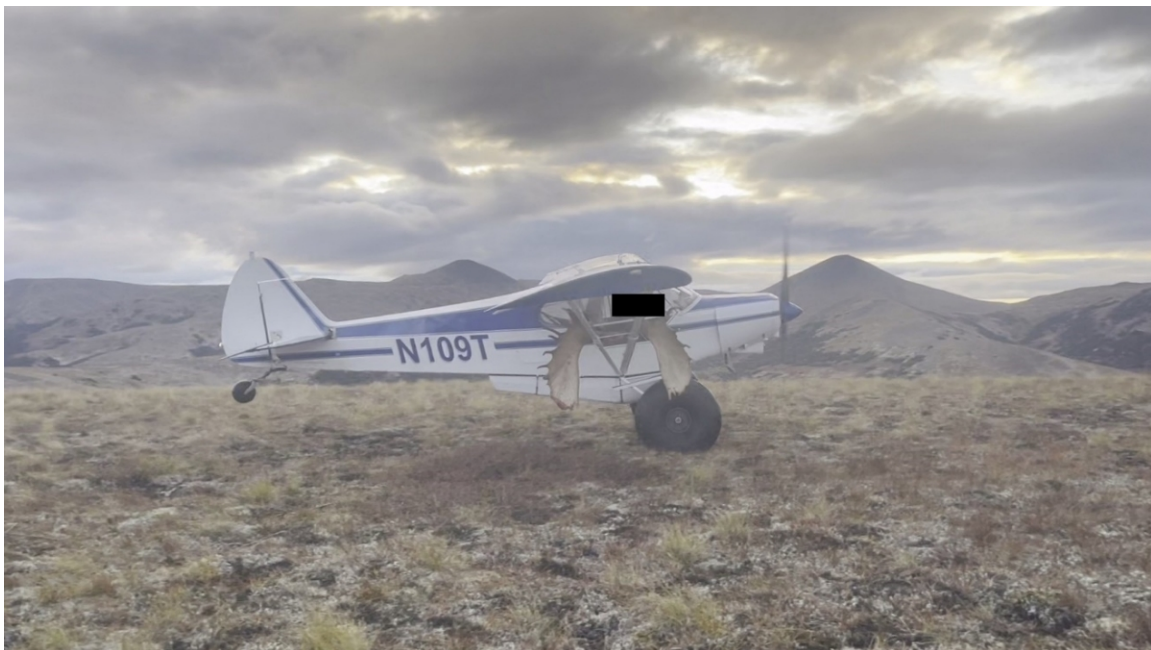
One of the hunters recorded a video of the accident takeoff. The video showed that the airplane began the ground roll at the southern end of the airstrip and departed to the north and uphill. The flaps were retracted, and the tail of the airplane came up as soon as the pilot applied engine power (see figure 1). The ground roll lasted about 530 ft, and, immediately after takeoff, the airplane pitched up and rolled about 20° right. The airplane then appeared to roll to a wings level attitude. The video ended a few seconds later. The engine was heard operating during the recording, and the airplane was not trailing smoke or vapors.

Figure 1. Airplane during the takeoff roll (Source: Hunter video) Note: The figure shows the antlers attached to right wing strut.

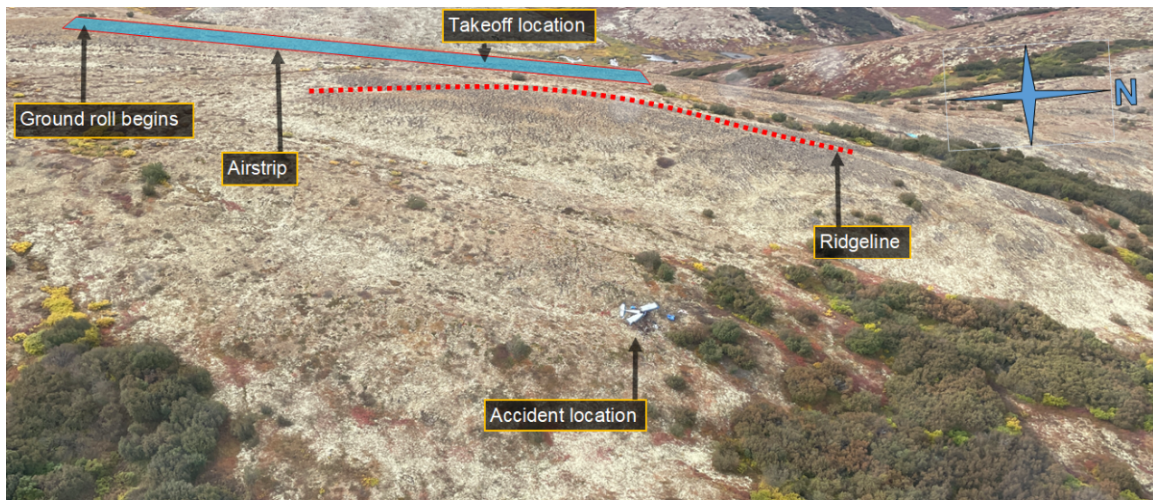
A team comprised of the National Transportation Safety Board investigator-in-charge and technical representatives from the Federal Aviation Administration, Piper Aircraft, and Lycoming Engines responded to the accident and arrived on site on September 15. Examination revealed that the airplane came to rest on a 30° downward slope on the other side of the adjoining ridgeline, at an elevation of 1,210 ft mean sea level, about 10 ft lower, and 600 ft east of the departure end of the airstrip (see figure 2). The surrounding area consisted of rolling hills covered in tundra, grass, and low-lying shrubs and bushes.

Figure 2. Accident site.

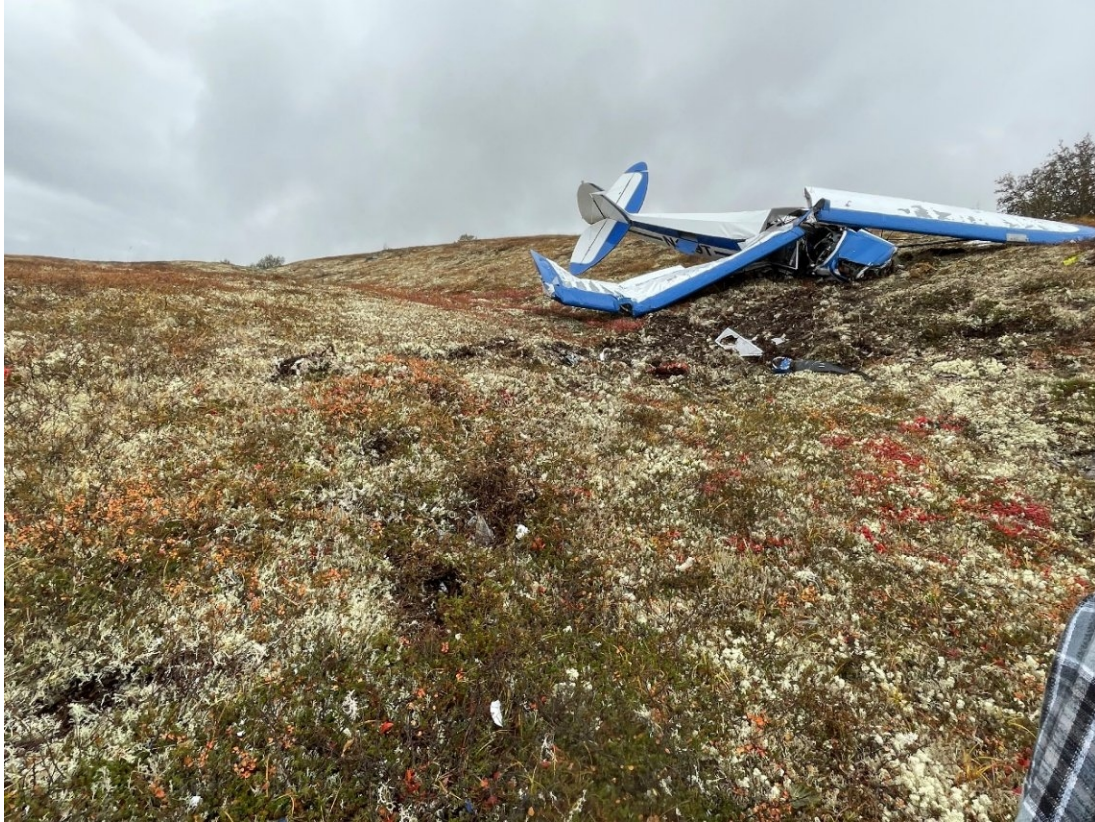
The fuselage was on a north heading, and both wings remained partially attached and generally in line with each other on a northwest-southeast orientation. The first identified point of impact, which was located about 20 ft below the main wreckage, consisted of a divot in the soil that contained blue and white fragments that matched the right wingtip (see figure 3). Next, the right wing landing light assembly and right window frame were located about 5 ft uphill in a west direction. A large divot in the soil, which was located 5 ft farther uphill, matched the general dimensions of a main landing gear tire. Adjacent to this hole was the propeller, which had separated from the crankshaft.

Figure 3. Accident site with the first point of impact in the foreground.
