# Aviation Investigation Preliminary Report

<b>Location:</b>	Fairbanks, AK	<b>Accident Number:</b>	ANC24FA029
<b>Date &amp; Time:</b>	April 23, 2024, 10:03 Local	<b>Registration:</b>	N3054V
<b>Aircraft:</b>	Douglas C54D	<b>Injuries:</b>	2 Fatal
<b>Flight Conducted Under:</b>	Part 91: General aviation - Business

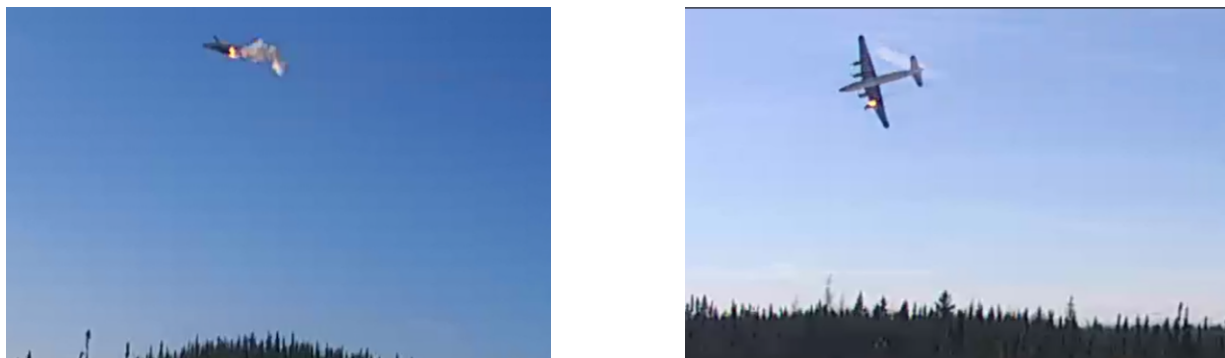
Figure 1. Surveillance Video Clips

The accident airplane, owned and operated by Alaska Air Fuel, Inc., was transporting 3,400 gallons of unleaded fuel and two 100-gallon propane tanks. The airplane departed from the Fairbanks International Airport (FAI) at about 0955 Alaska daylight time (AKDT) with a destination of the Kobuk Airport (OBU) Kobuk, Alaska. Shortly after takeoff an eyewitness reported seeing the airplane flying to the west, with the far left engine (No. 1) not running. The witness also noticed a small, white plume of smoke coming from that engine. The witness reported the airplane began a turn to the south at which point he noticed the engine was on fire. Recovered surveillance video shows white smoke behind the number one engine, followed by flames. The video also revealed that seconds later a bright white explosion is seen just behind the number one engine followed by fragments of airplane wreckage falling to the ground. See figure 1.

The airplane then begins an uncontrolled descending left turn into terrain. The No. 1 engine separated from the wing about 100 ft above the ground and eventually came to rest on the frozen Tanana River.

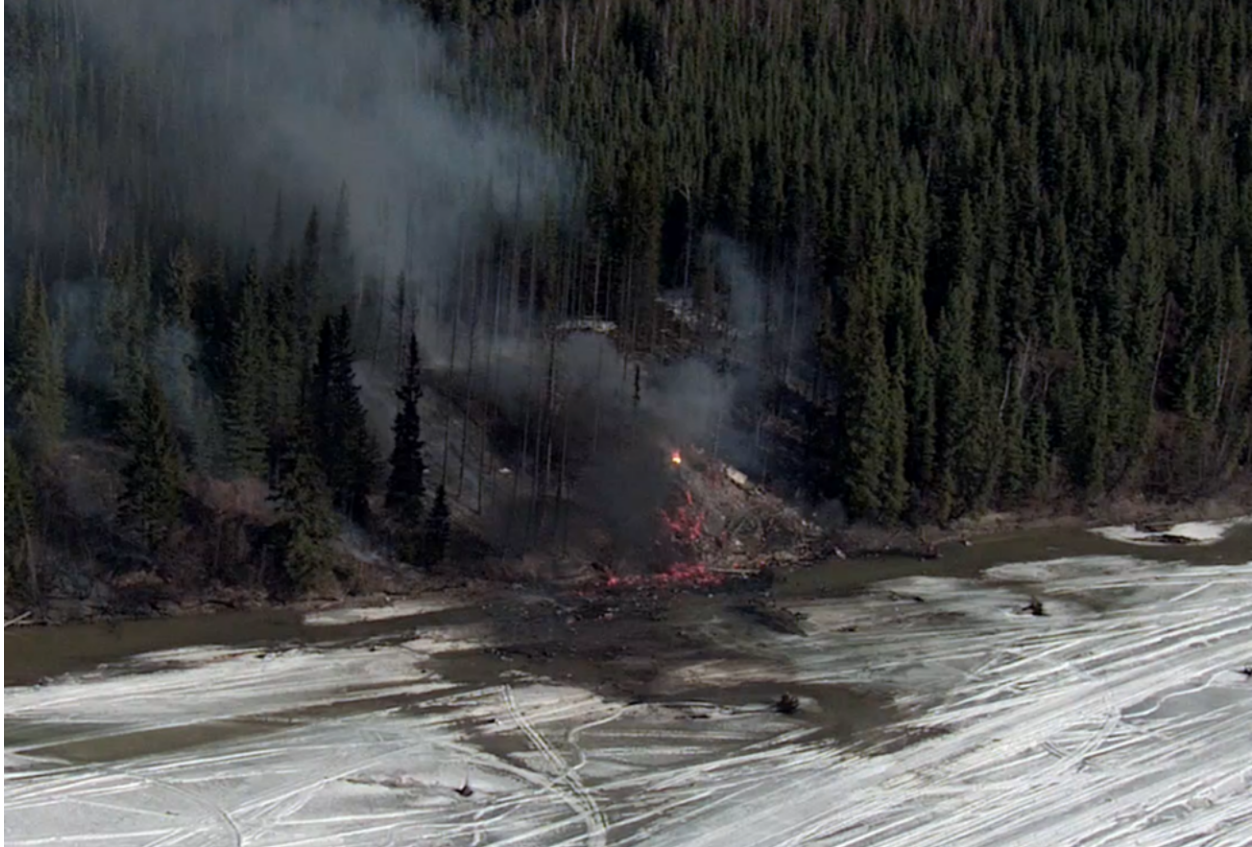
Figure 2. N3054V accident site. (Alaska State Trooper Photo)

A large postcrash fire ensued, which incinerated much of the airplane's structure. See figure 2.
